Manhole Inspection Summary

Manhole # S11O__015MH

Insp Date: **4/15/08 10:11 AM**

Location Address: **3119 Stafford St**

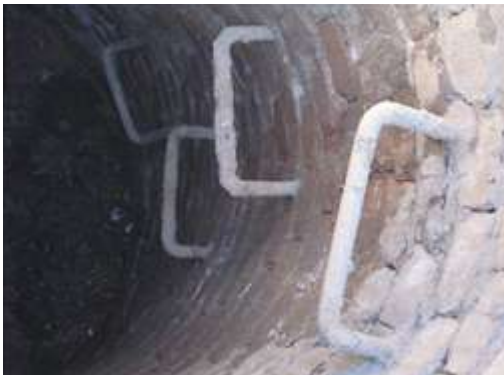
Defect 2

Steps Count: **4** Missing: **0** ☒ **Corroded**

corroded steps

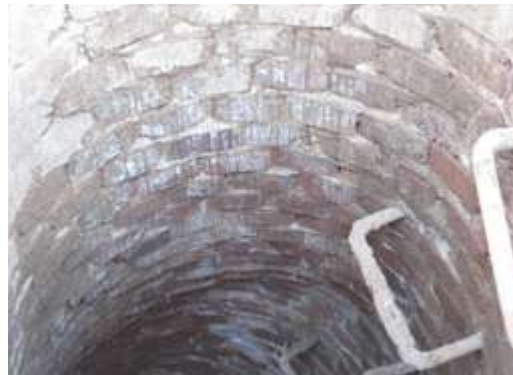
Defect 6

Infiltration: ☐ None ☐ Joint ☐ Cracks ☒ **Mortar** ☐ Roots ☒ **Wall**

infiltration at corbel

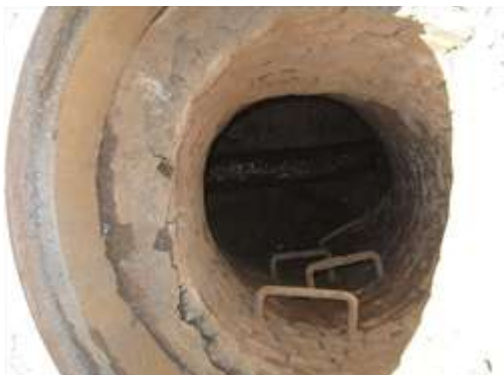
Defect 5

Frame Offset: **4** (in.) Condition: ☐ Sound ☐ Cracked ☒ **Leaks**

frame offset

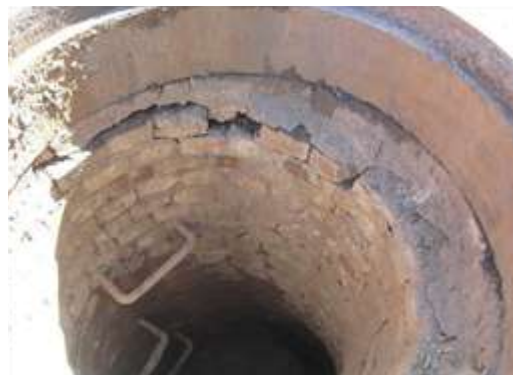
Defect 1

Condition: ☐ Sound ☐ Cracked ☐ Root Intrusion ☒ **Loose Brick** ☒ **Deteriorated**

loose bricks and mortar under frame

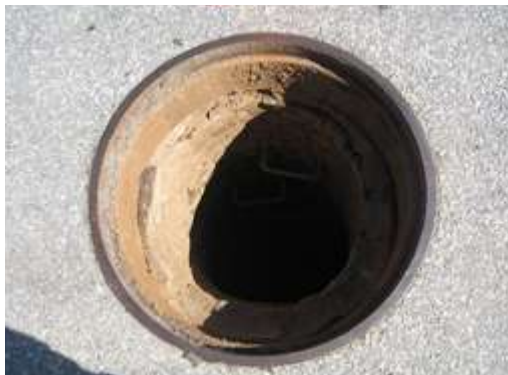
Defect 4

frame leaks

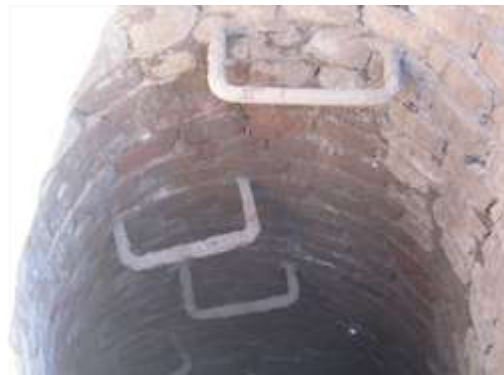
Defect 3

Infiltration: ☐ None ☐ Joint ☐ Cracks ☐ Mortar ☐ Roots ☒ **Wall**

infiltration at corbel and barrel

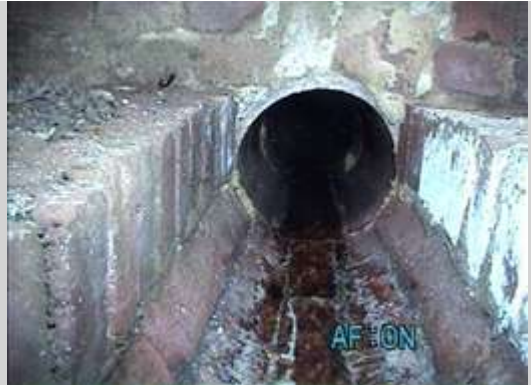
12 O'Clock Outflow

Pipe Height: **8.4** (in.) Rod and Bar (Angled)
Pipe Material: **Clay** ☐ Pipe Lined
Invert Depth: **9.07** (ft.) Flow Characteristics: **Fast**
Deposits: ☒ None ☐ Mud ☐ Sludge ☐ Debris ☐ Grease
Silt Depth: **0** (in.) Deposits Extent:
Infiltration: **None** Pipe Seal Cond: **Sound**

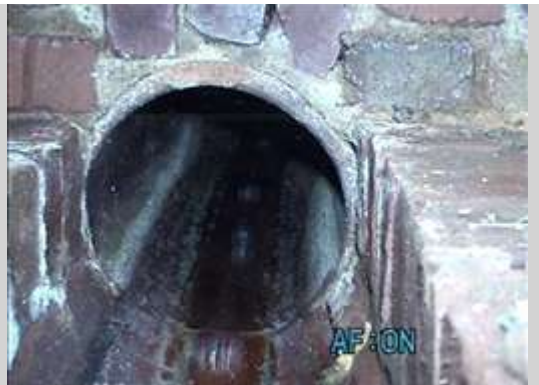
6 O'Clock Inflow

Pipe Height: **7.2** (in.) Rod and Bar (Angled)
Pipe Material: **Clay** ☐ Pipe Lined
Invert Depth: **9.01** (ft.) Flow Characteristics: **Fast**
Deposits: ☒ None ☐ Mud ☐ Sludge ☐ Debris ☐ Grease
Silt Depth: **0** (in.) Deposits Extent:
Infiltration: **None** Pipe Seal Cond: **Sound**
